NASA Contractor Report 159056

Repair Techniques for Graphite/Epoxy Structures for Commercial Transport Applications

**R.H. Stone
Lockheed-California Company
Burbank, California**

**Contract NAS 1-15269
January 1983**

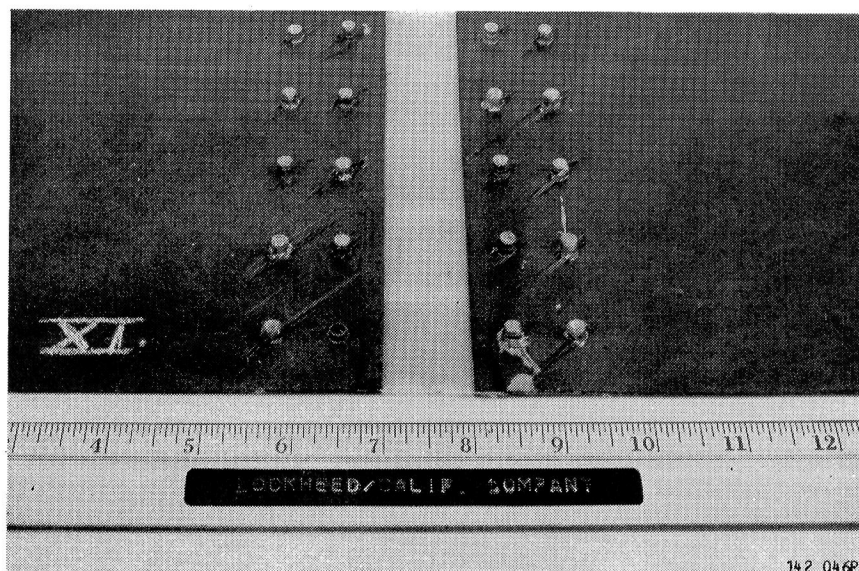
Figure 23. - Back-face of bolted repair (Type XI) showing splitting from single-side drilling and showing filler.

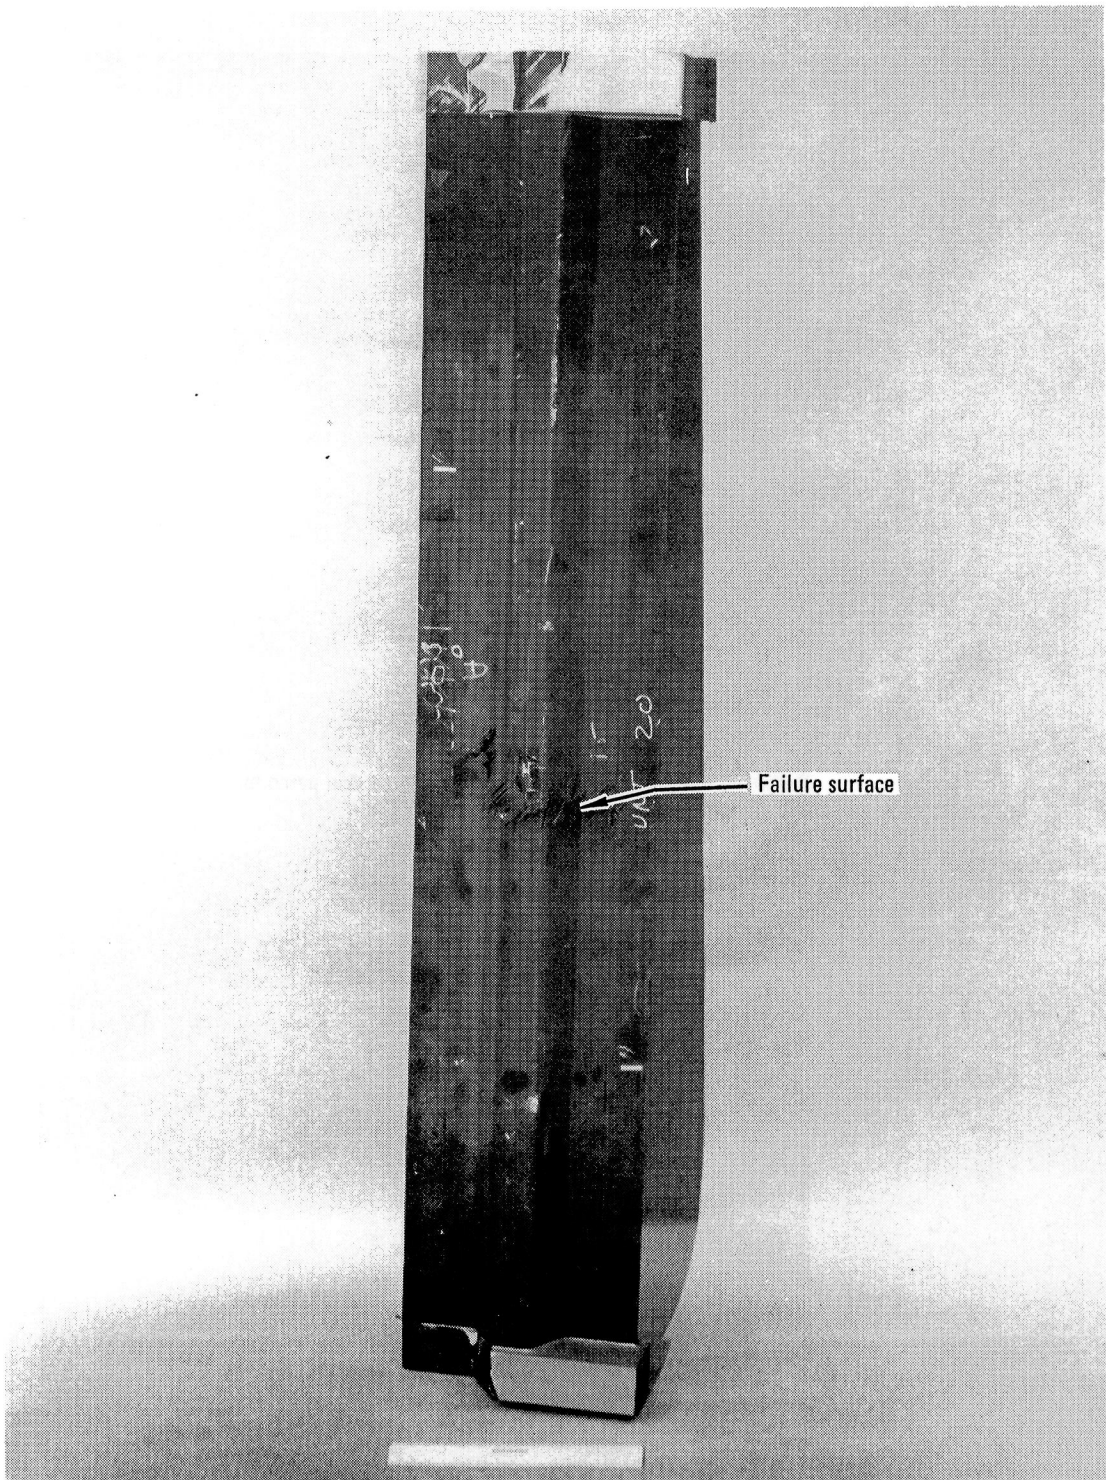
Figure 74. - Failure of the Type I control specimen.

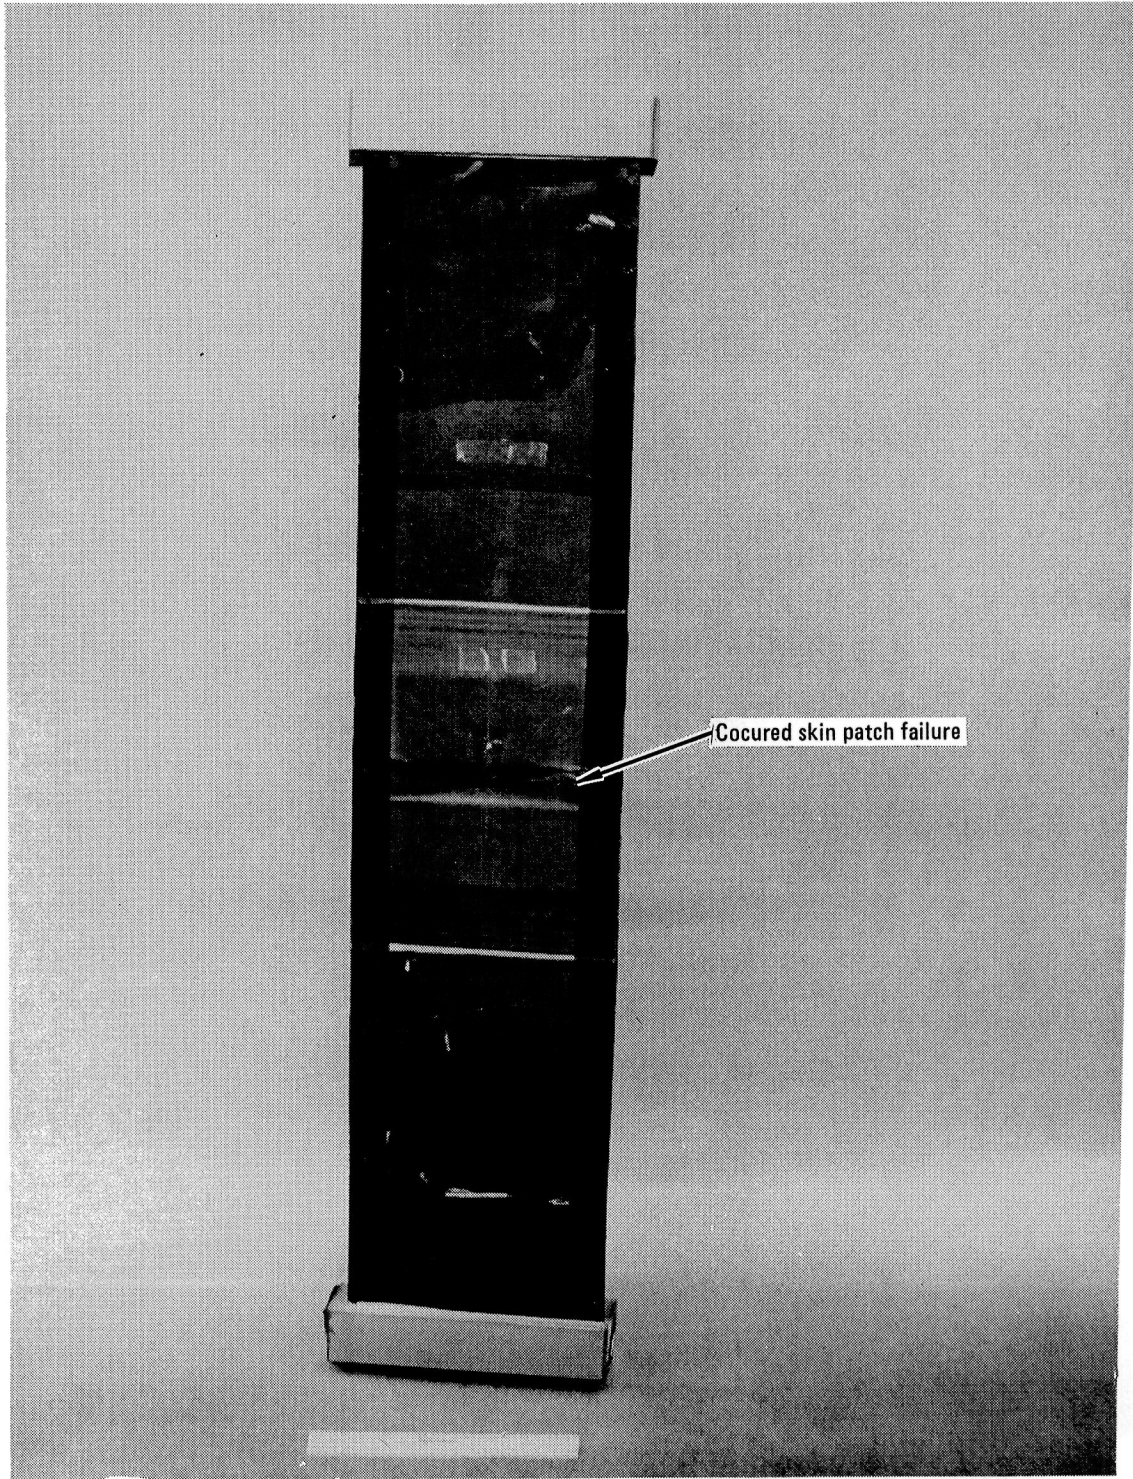
Figure 75. - Failed Type I repaired specimen.

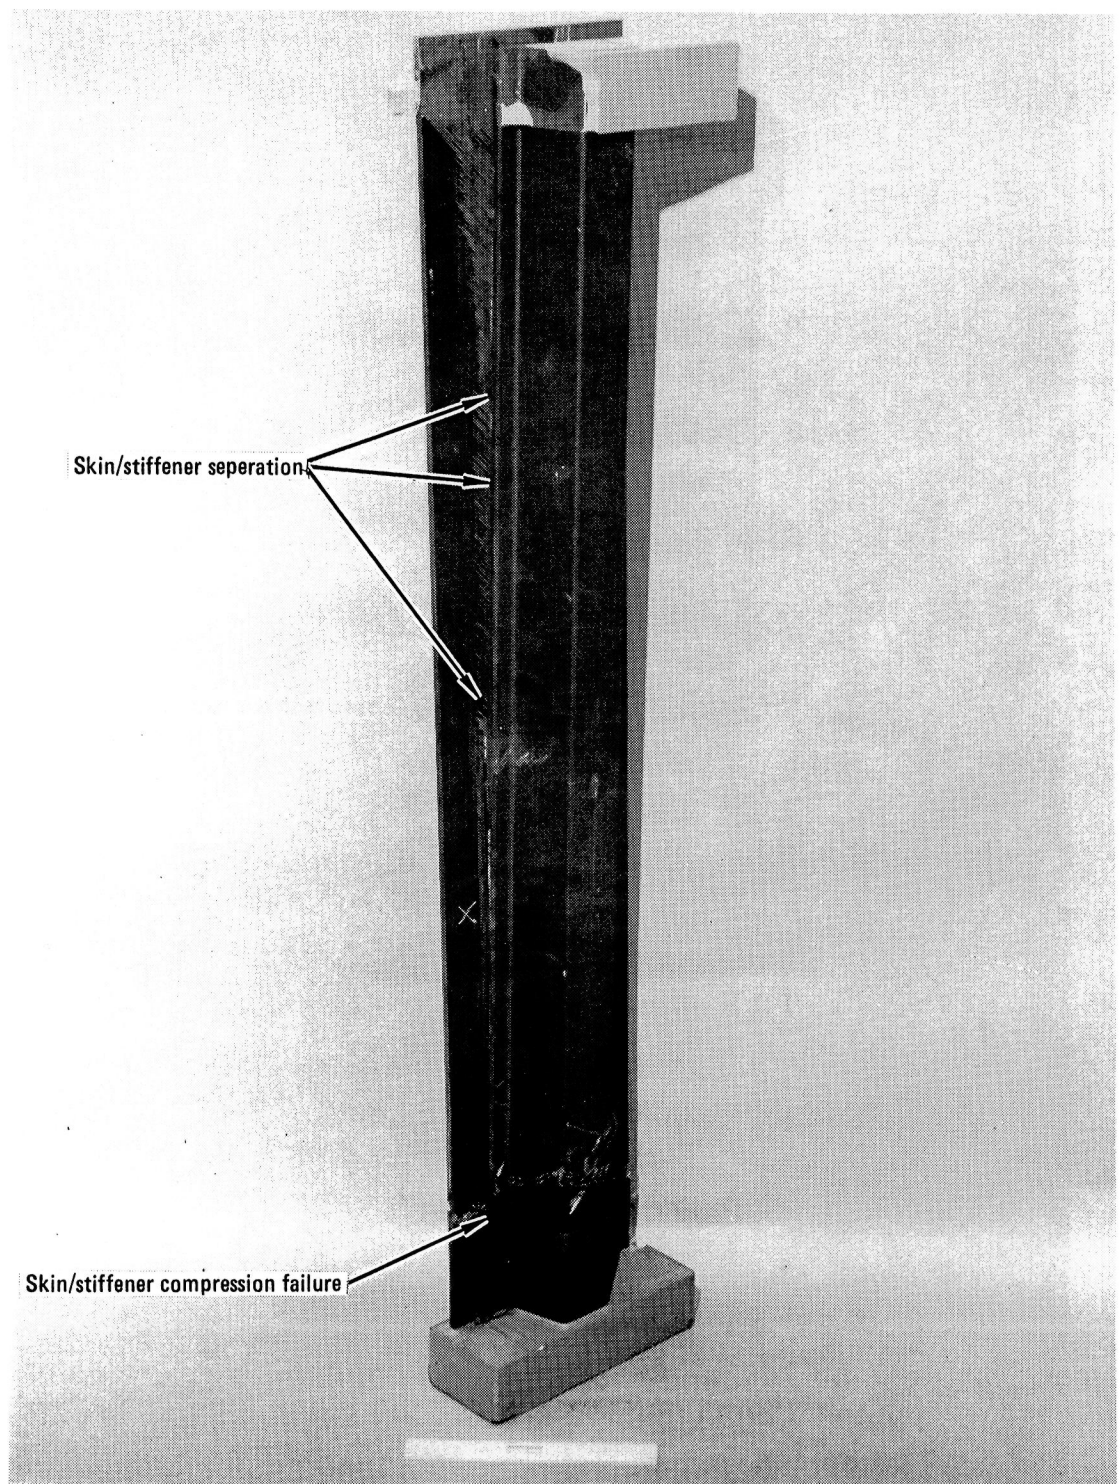
Figure 76. - Failure of the Type II control specimen.

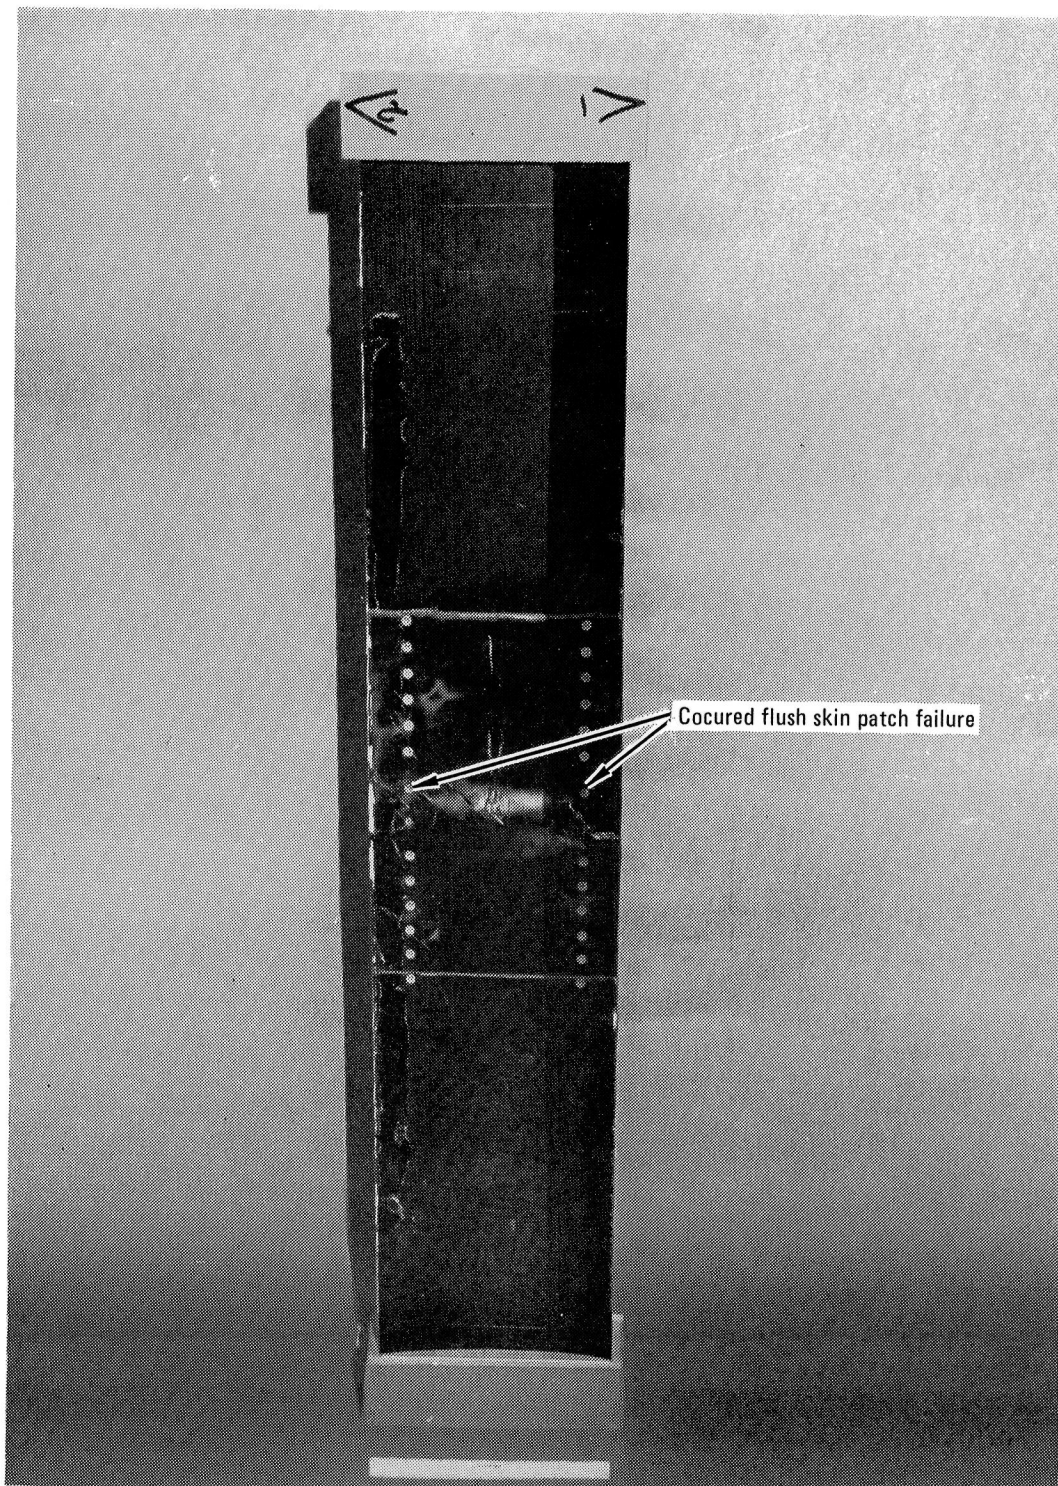
Figure 77. - Skin patch side of Type II repaired specimen failure.

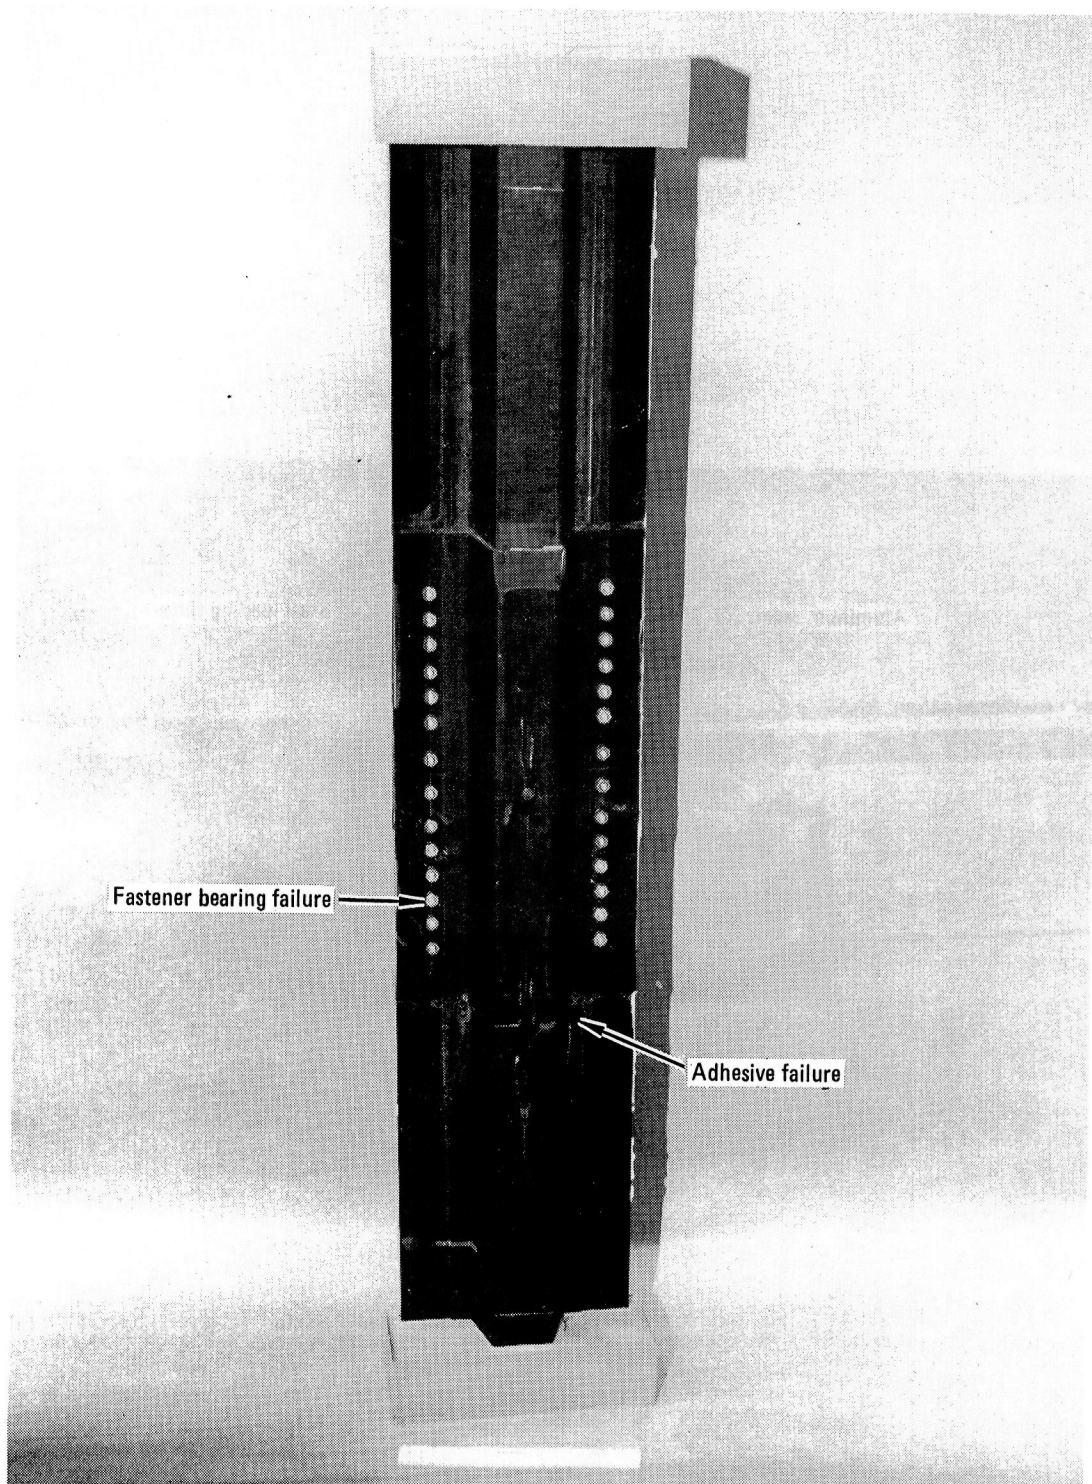
Figure 78. - Hat side of Type II repair specimen failure.

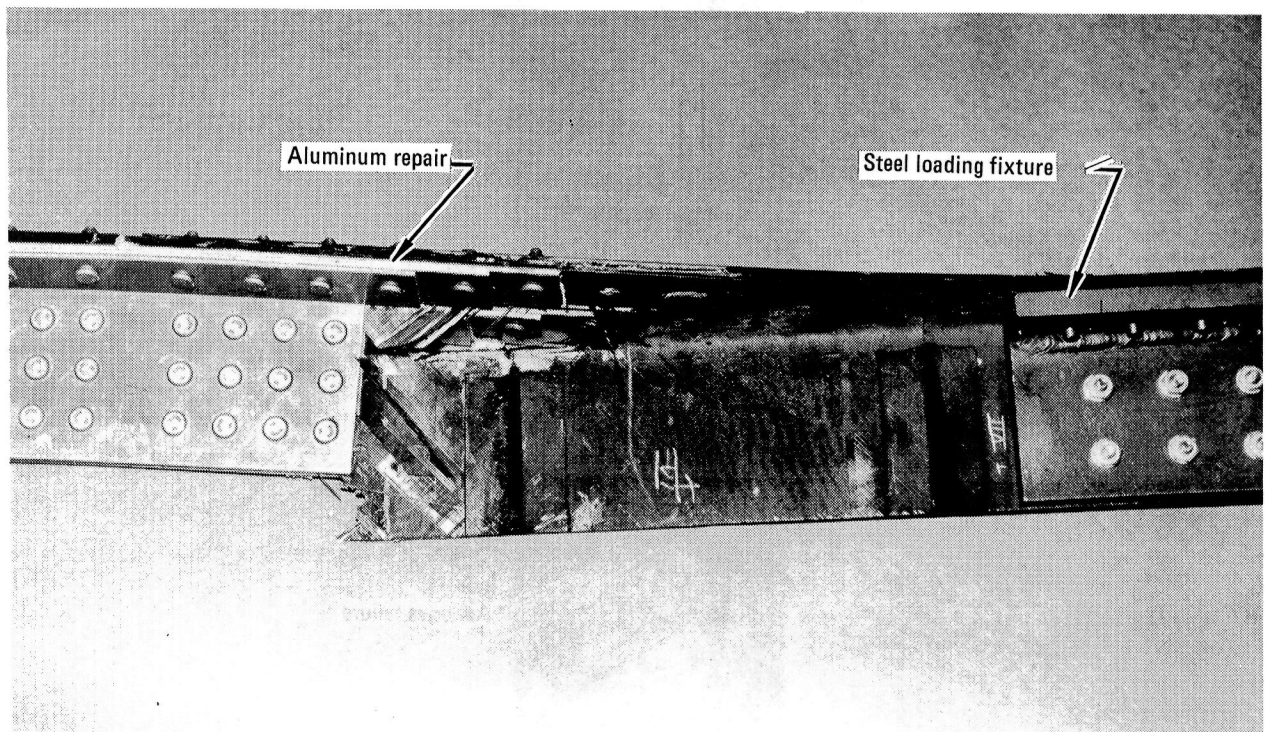
Figure 79. - Type III repaired specimen failure.

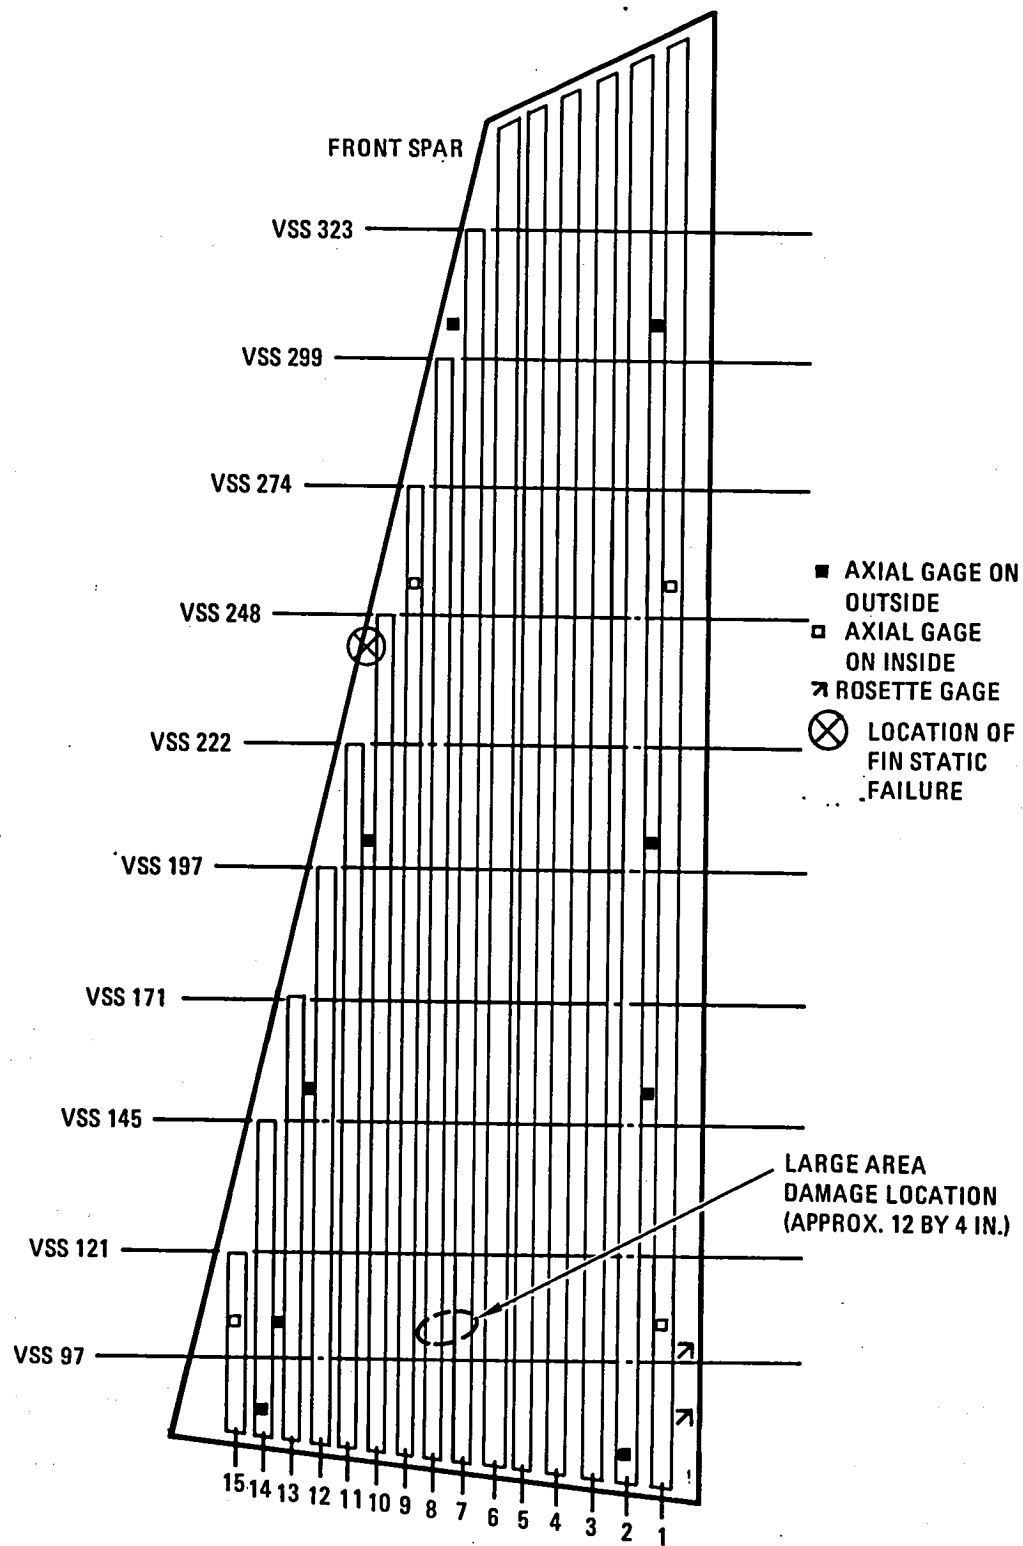
Large area damage, representative of lightning strike damage, was inflicted on the ACVF cover and adjacent hat stiffeners following two lifetimes of fatigue cycling. A bonded external precured graphite patch was applied to the skin, followed by mechanical attachment of the disbanded stiffeners to the repaired skin. After repair, the fin GTA was subjected to one additional lifetime of fatigue cycling, followed by loading to ultimate strength and failure.

Figure 80. - Large area damage location on vertical fin GTA.

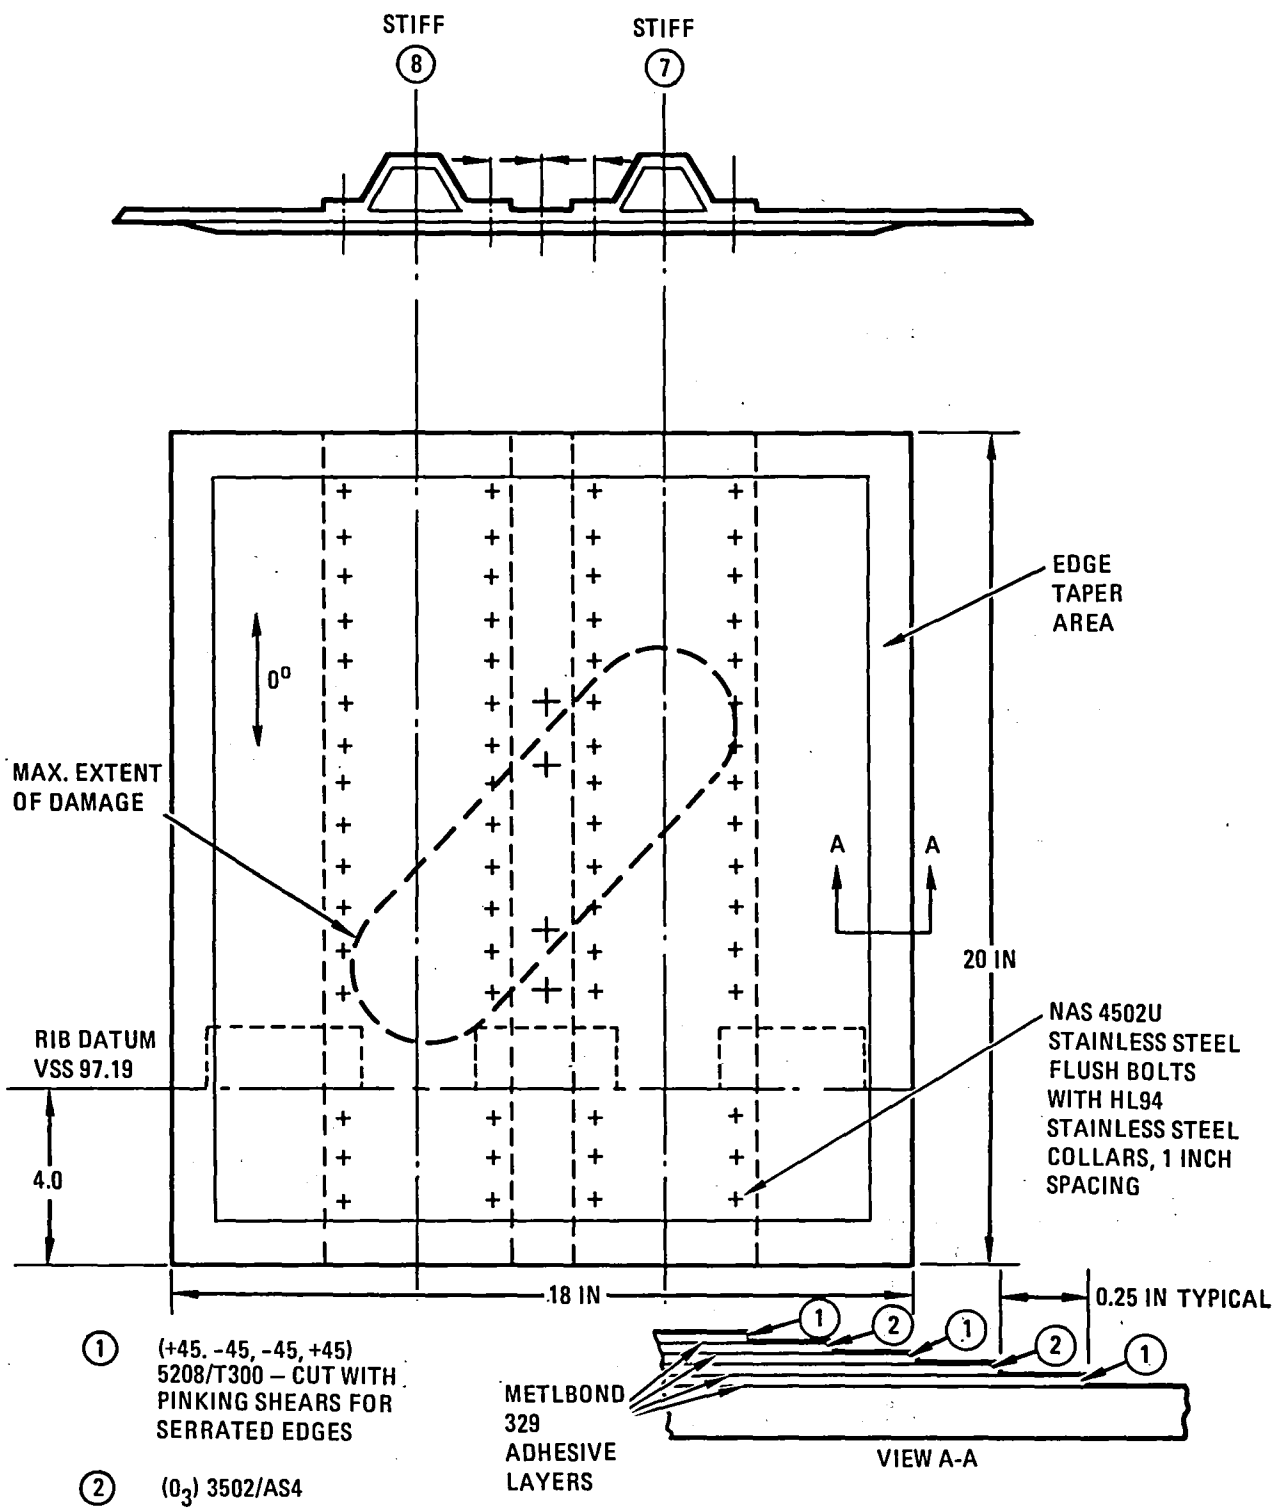
Figure 81. - Repair patch and damage area on fin component.

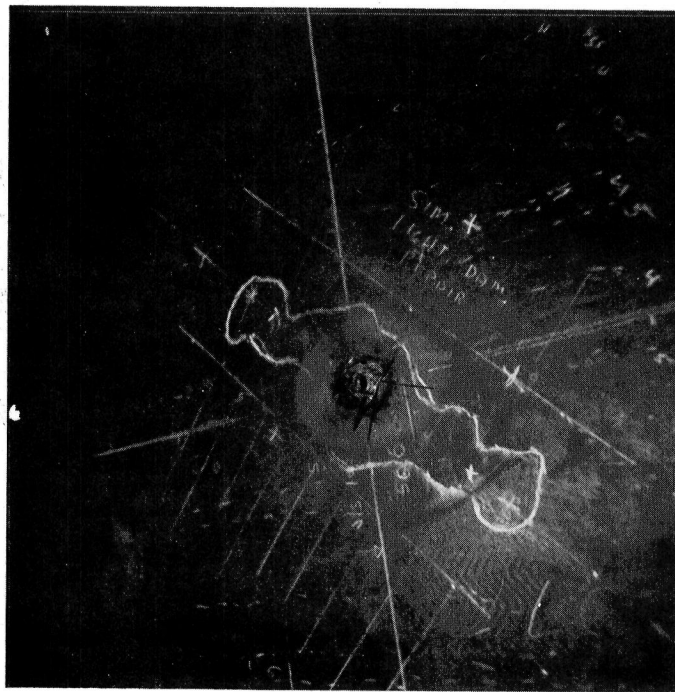
Figure 82. - Through penetration damage and marked area of delamination (before charring).

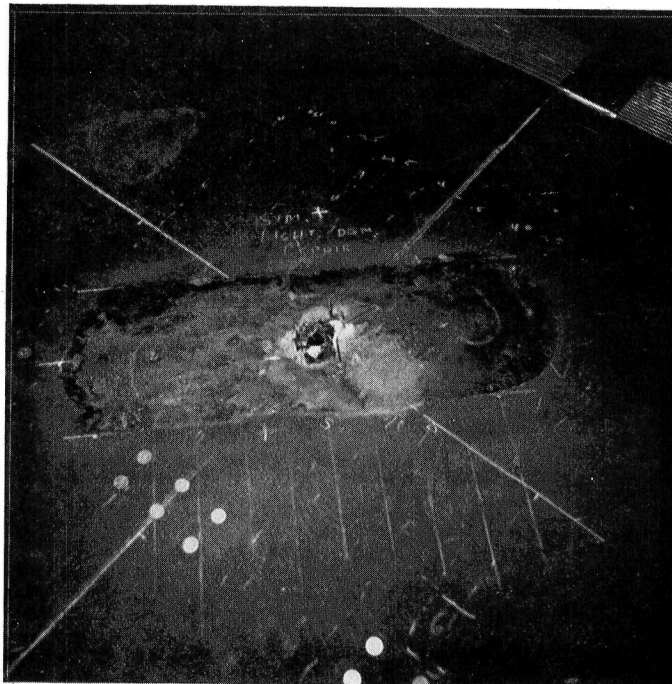
Figure 83. - Through penetration damage surrounded by charred area.

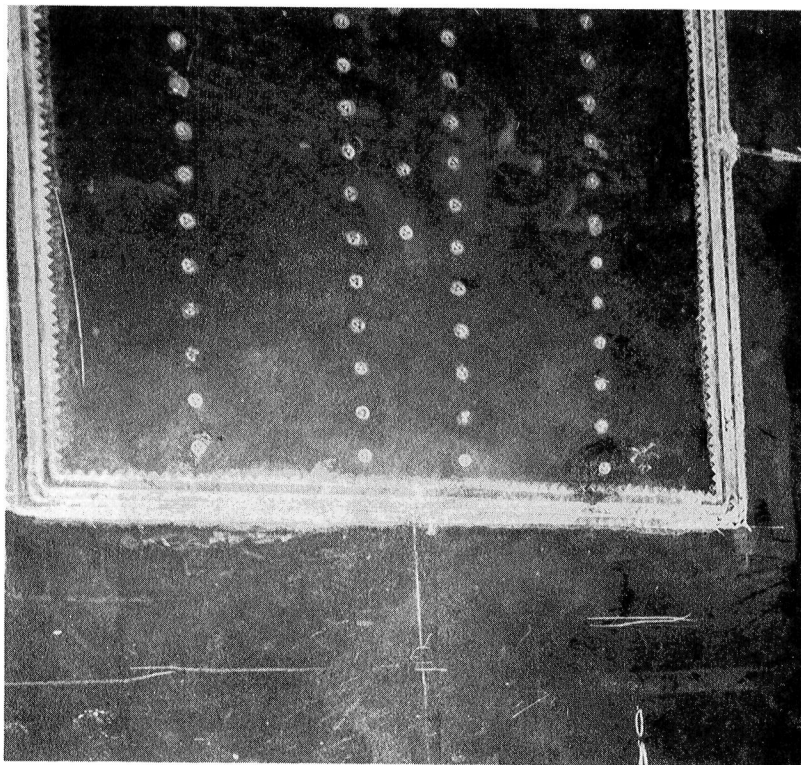
The fin GTA failed at 120% of design ultimate load. The repair patch remained intact and unaffected by the fatigue cycling and testing to failure. Strain measurements indicated no effect of the patch on far-field strains in the fin component.

Figure 85. - Repair patch on vertical fin ground test article.
